ANDOVER ESTATE

November 2015

UPDATE REPORT ON THE DAMPNESS / CONDENSATION WORKS PILOT WORKS.

Recommendations on the way forward to the rest of the similar
type units

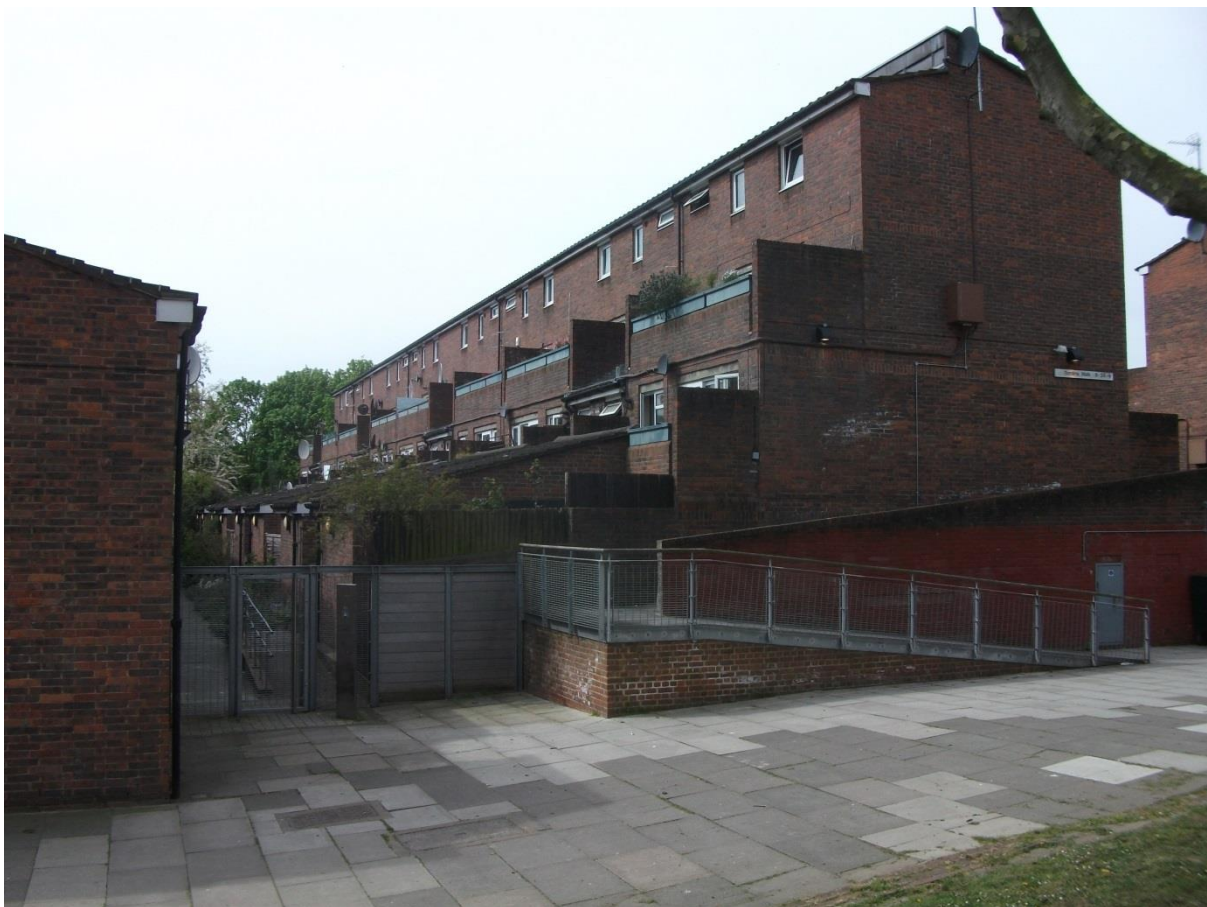
Figure 1 Balconies above bedroom and hallway and pitched roof above the living room to the ground floor flat entrance. Elevation of a typical four storey block with individual garages behind.

- d) Condensation and its effects occurs to and is most prevalent underneath the front first floor flat balcony roof and double pitched roof areas to the habitable bedroom, living room and hallway of these flats. This is where cold bridging is noticeable and where insulation was found to be minimal. In many instances the external balcony insulation has either decayed, broken down or it has been removed and where it is present, it does not cover the full balcony surface area.

Externally: Insulation will now be fitted to the sloping living room roof void from the outside in lieu of internally to the living room ceiling thus reducing resident disruption and disturbance to the internal 'Artex' finishes to ceilings which contain an element of asbestos. A further consequence of will be a reduced overall cost. The detail to the balcony skirting will be amended to also include insulation on all up-stands.

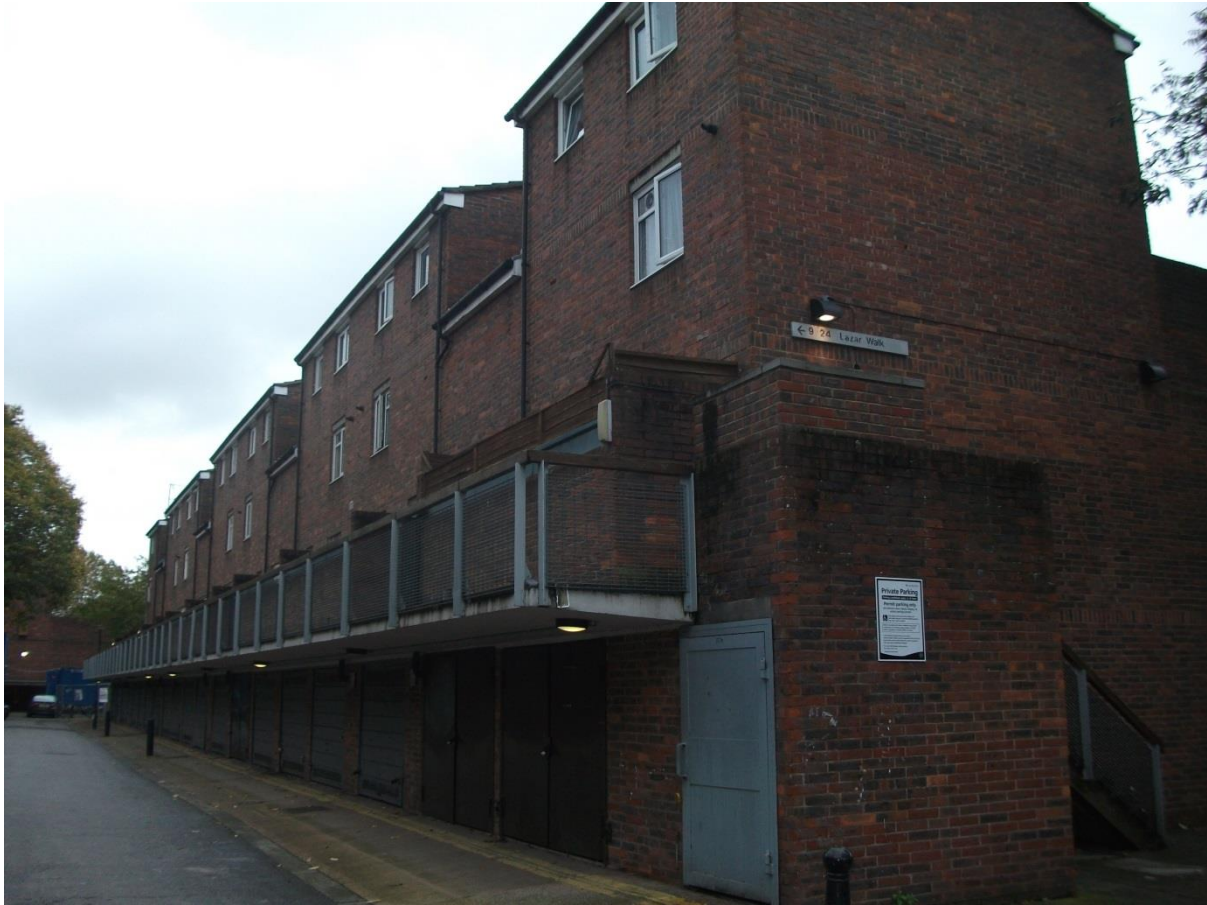
- a) The garages are unheated, they have poor levels of insulation and the wall dividing them with the flat behind is a solid masonry wall. Condensation occurs to the various flat cupboard walls and bathroom adjacent to the garages.

Figure 2 Typical four storey block- with individual garages at ground floor level. These back directly onto the ground floor one bedroom flat units.

The insulation will now be fitted to the garage side to the rear wall of the bathroom, bedroom and the kitchen. Some enforcement may be required where access to garages is not forthcoming.
