MPS Crime Prevention & TP Capability Environmental Visual Audit (EVA)

BCU	Islington
Problem	Drug related death of customer - 25/06/2016
Area/Address	Fabric (nightclub), 77a Charterhouse Street, Clerkenwell, London, EC1M 6HJ
Prepared for	Chief Inspector Jennifer East MPS Central Licensing Team
Prepared by	DOCO Karl Turton
Date approved	04/08/2016

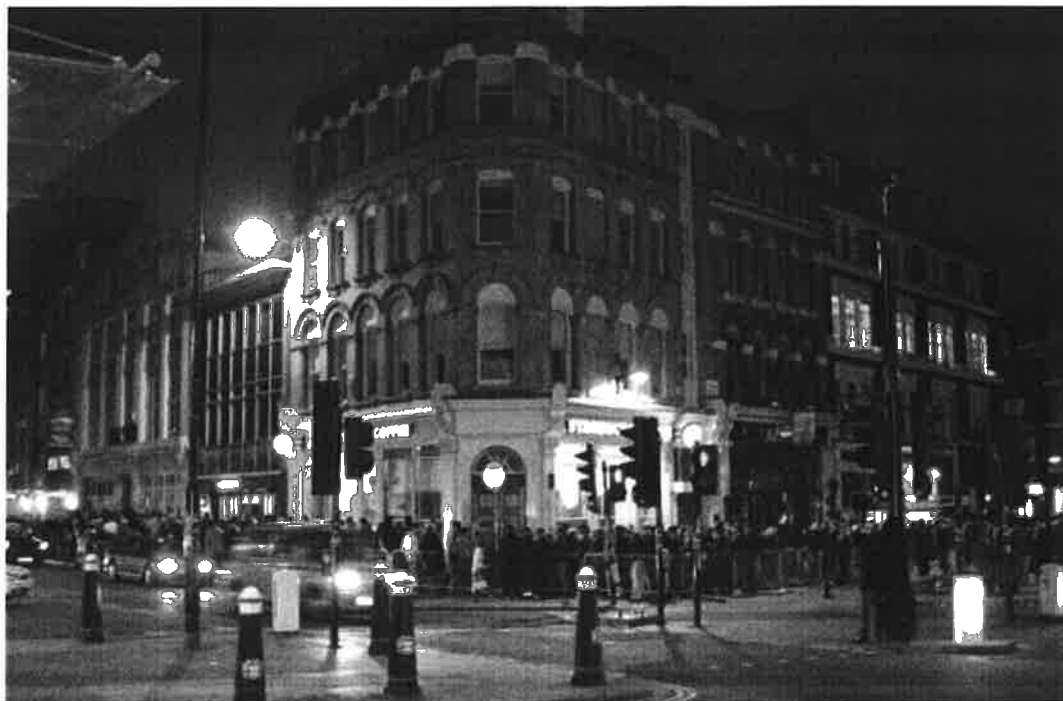
Typical queue system used at Fabric

All who seek to enter the club are required to queue directly outside the venue in Charterhouse Street and line up heading west. The queue can stretch all the way in to St John Street and Cowcross Street. The queue system is affected by the lack of space outside the club entrance with three separate lines filling the pavement, making anyone looking to walk along that section of pavement divert into the road and in to oncoming traffic and, as such, is a hazard.

There is also no cab or vehicle drop off point either forcing taxis to pull up in the carriageway directly adjacent to the main doors of the club, further adding to congestion. This creates a chaotic space with significant hazards to both vehicles and pedestrians.

1. Restructure the queue so that access to the venue is through the rear of the club via Greenhill Rents which is currently blocked off by the venue. Clarity over control over this location would need to be confirmed prior to any adaptations being planned. The rear smoking area occupies only part of the exterior space utilised by the club when it trades, as during the visit a number of motor vehicles were parked in a sectioned off area close to the rear of the club. This could allow a higher number of prospective patrons to be accommodated within a protective perimeter. In turn, moving the displaced smoking area to the front elevation in a pen constructed from temporary fencing. This would reduce the impact on neighbouring properties. This would also assist with vehicular congestion at the junction with Charterhouse Street and St John Street.

5. Continue with the queue system in its current form for walk up customers and support this with further security staff at regular intervals along the queue, who are issued with body worn video and part of the club's radio linked system. This would help deter ASB and drug dealers from the queue, as well as help identify patrons looking to pre-load prior to entering the club.

8. The amount of pavement monopolised by the club needs to be reduced to allow the public to navigate past the venue safely. Pre-paid and VIP customers could use the rear entrance via Greenhill Rents, which would help reduce the need for three alternative queues.
